SAFETY ALERT

Safety Alert No. 345
25 January 2019

Sprag Brake Clutch Failure Leads to Near Miss

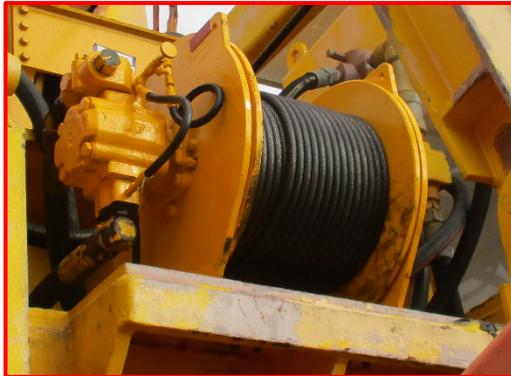
Figure 1: The replacement winch. This winch is similar to the one that was involved in the incident.

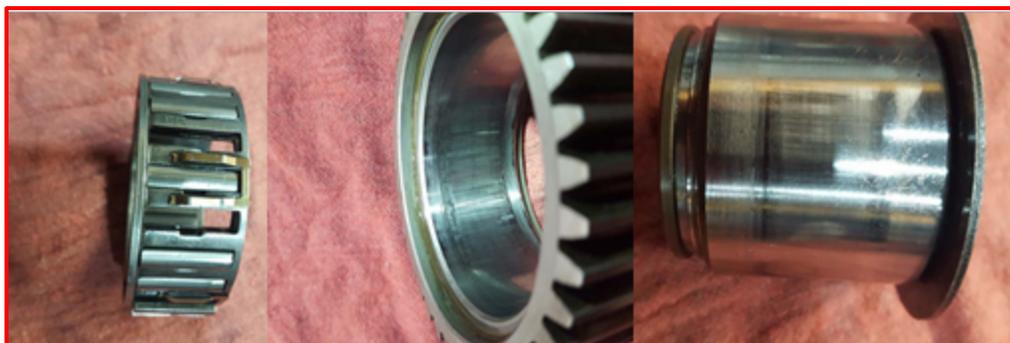
Figure 2: The disassembled sprag brake clutch

When disassembled, it was found that the sprag brake clutch was not as tight and rigid as normal and would randomly slip in certain positions. After disassembly, the sprag clutch was found to have abnormal marks on the outer and inner surface of the sprag components potentially caused by shock loading and/or faulty components.

- Look for warning signs of a sprag brake clutch malfunction (e.g. slipping after the winch stops). Crane operators should report any abnormal behavior to mechanics and facility management.

- Verify control mechanisms including brakes and clutches for proper operation in compliance with API RP 2D C.4.1 (6th edition) and manufacturers recommendations during pre-use, monthly, quarterly, and annual inspections.

- Winches should be periodically disassembled and all wear items should be inspected for damage. Typical inspection intervals are one to five years, and may vary depending on frequency of use. Refer to the manufacturer's recommendations and applicable industry codes such as API RP 2D (Section C.4.1). Consider ASME Spec B30.5-2004 (chapter 5-2) for guidance.

- If you do not have records of the last winch disassembly and the winch is over five years old, limit use of the winch and schedule a disassembly and inspection soon.

- Conduct periodic oil sampling and analysis.
 - Record and trend results over time – high levels or sudden increases in iron contaminants may indicate serious mechanical problems. Disassembly of the winch may be required to determine the cause.

- Oil should be changed regularly, typically annually. Use only the oil type specified by the manufacturer. Improper oil may lead to brake clutch slippage.

- Conduct a winch warm-up procedure at crane start-up to help prevent brake slippage. This is especially important during cold weather.
- Avoid shock loading the crane. If you suspect that a crane has been shock loaded, safely lower the load, remove the crane from service and follow the manufacturer recommended inspection procedures to verify that the crane has not been damaged.
